Field Trial: San Francisco Mall – Facility Summary

Commencing Date: 6/27/2007

Study Description: Observe and document the effectiveness of Green Bull Drain Cleaner and Grease Trap Treatment over a 90-day period

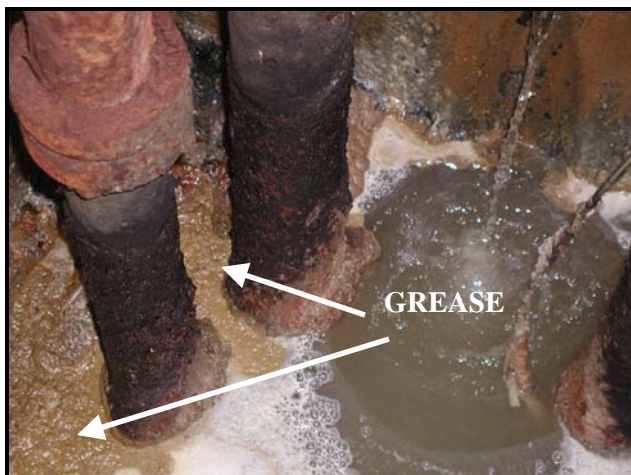
Sump Station 3 Wet Well

BEFORE

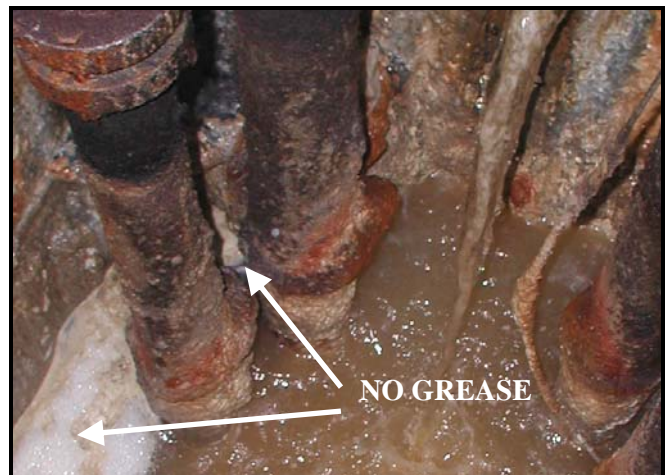
Sump Station 3 Wet Well

Observations: All locations are demonstrating remediation in varied degrees dependent on flow volume and site-specific factors. All locations have reversed the process of grease accumulation and are exhibiting reduction of accumulated mass.

AFTER

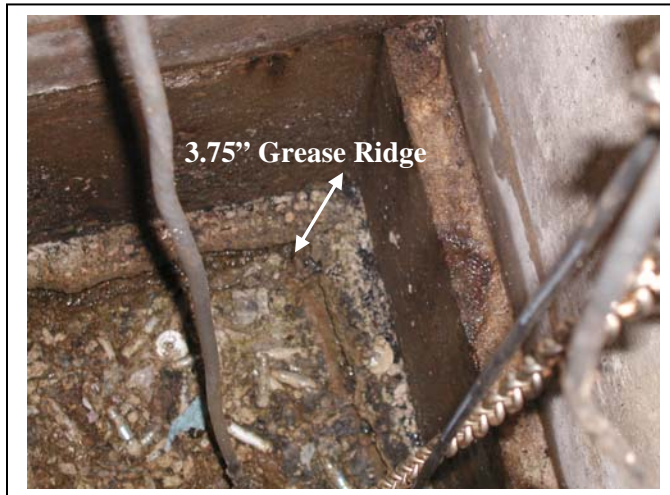
Sump Station 2 Wet Well

Grease Ridge on 6/27/2007
